Terahop and Lawrence Livermore National Laboratory Structural Fire RF Testing

Peter Haugen, Garth Pratt

March 1, 2007

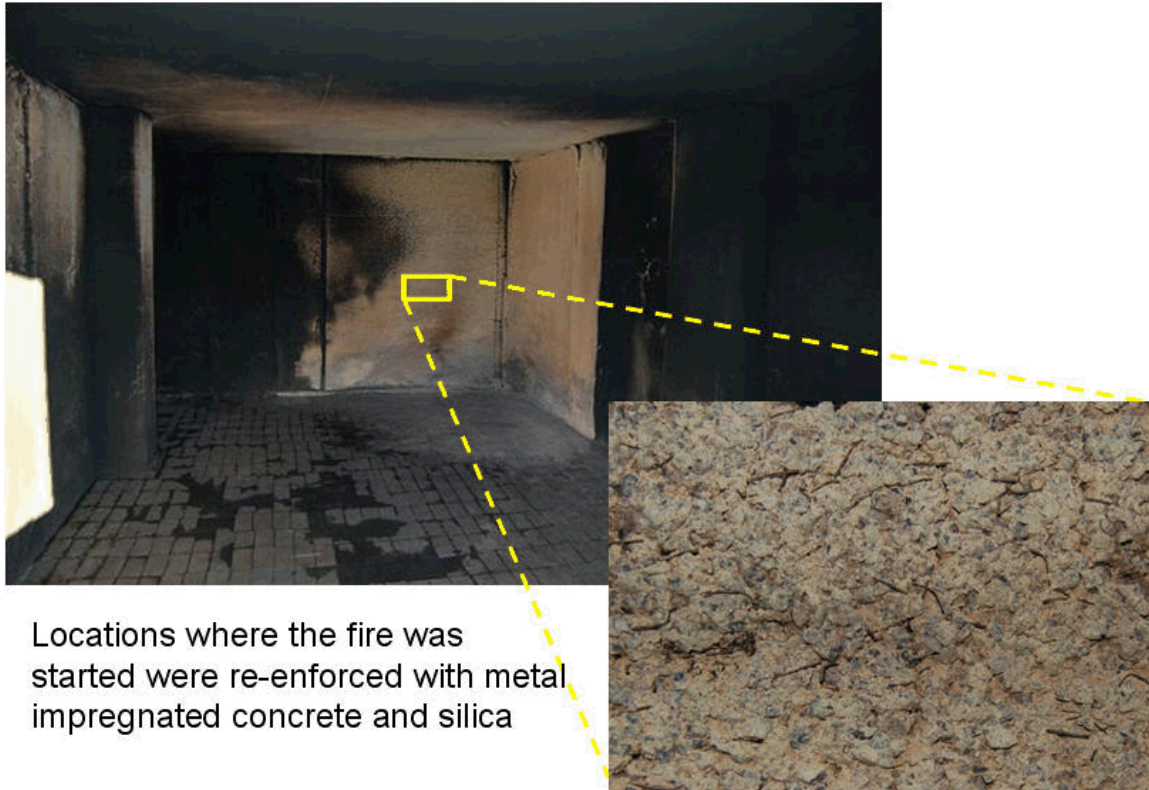
Locations where the fire was started were re-enforced with metal impregnated concrete and silica

Figure 3: Metal fibers in the wall materials

Unfortunately, RF transmission directly through the central location of the fire on the first floor was not possible, so the transmission path had to be shifted approximately 6' off the side of the fire's center. The corner where the fire was located on the first floor was re-enforced with a mixture of concrete and metal fibers for heat resistance. This material was highly reflective, permitting very little RF energy to pass through it. This phenomenon was also observed and verified by Terahop's testing, discussed in the next section. An image of these re-enforced walls and a close up of the actual wall material containing the metal fibers can be seen in **Figure 3** above.

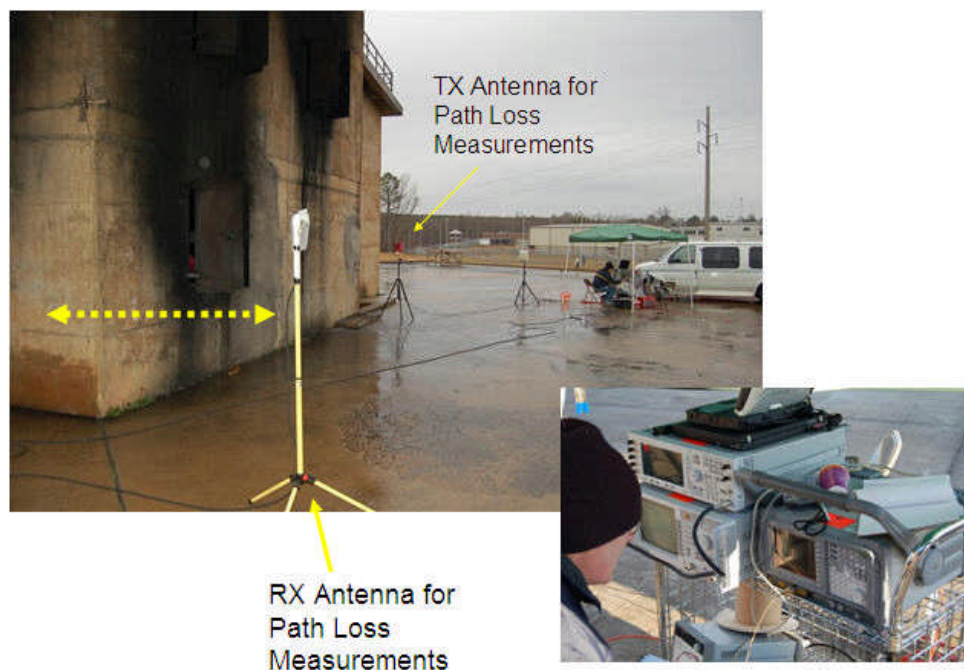
Figure 5: RF path loss and frequency penetration tests

Terahop collected data from two primary test methods. The first test was to perform measurements of how the structure itself and the fire attenuates RF transmissions in the primarily ISM bands (900MHz, 2.4GHz, and 5.8GHz). This was done by placing wideband RF antennas across a corner of the building (transmission directly through the building was not possible due to the power requirements and the metallic reinforced corners where the fire was located). Originally, a network analyzer was evaluated for data collection, but higher power levels were found to be required and the team ultimately ended up using a frequency synthesizer to generate CW information on the frequencies of interest while quantitatively measuring the received signal strength on a spectrum analyzer. The intent was to measure the loss at the desired frequencies with the building empty and then repeat those measurements with the fire burning to get a quantitative measure of the plasma effects on the frequencies of interest. **Figure 4** below shows a diagram of the basic antenna placement around the building during measurement and **Figure 5** shows the physical equipment setup and the antenna placement during calibration (the antennas were moved between a line-of-sight path for calibration and a path obstructed by the building for measurement).

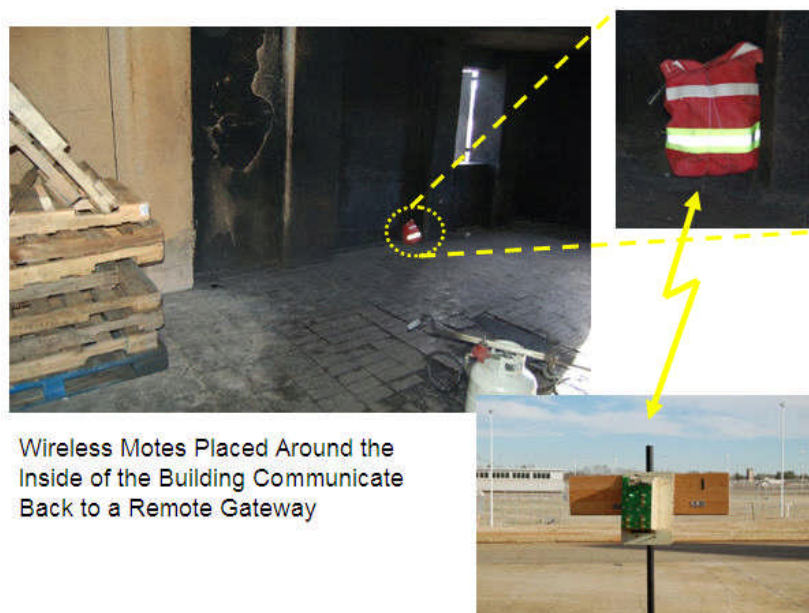
Figure 6: Deployable mote network inside building

In addition to low level RF path loss measurements, TeraHop brought and deployed a number of their wireless motes around on the inside of the building on the first and second floors. Their motes were wrapped in protective thermal enclosures and were scattered throughout the building to test RF connectivity during the exercises. These motes communicated via Bluetooth to gateway antennas deployed around the perimeter of the building. The mote placement locations near the fire on first floor are shown in the diagram in **Figure 4**. The mote's RF enclosures and exterior mote gateway transceiver can be seen in **Figure 6** below.

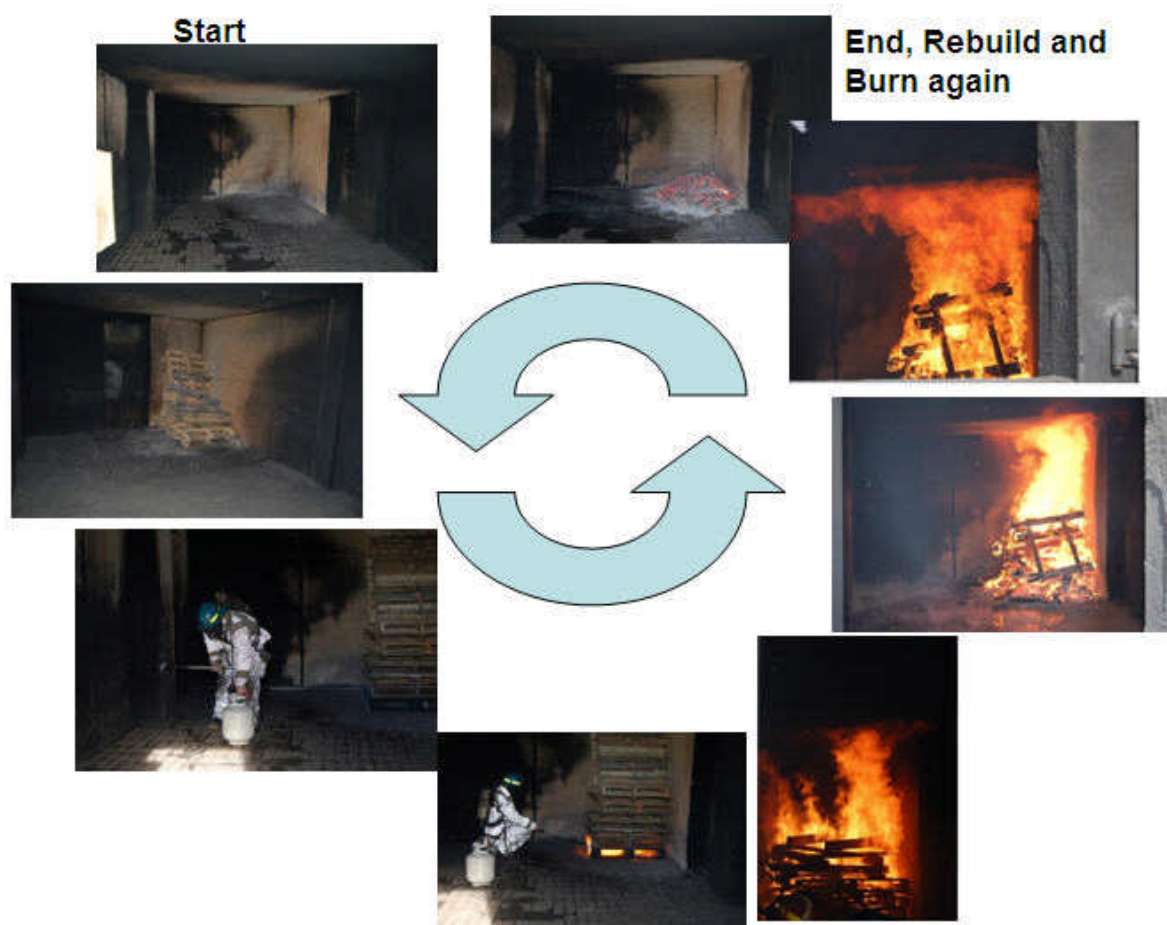
Figure 11: Fire ignition, training extinguishment, and re-ignition cycle

Following the test with the empty building, the firefighting exercises were commenced. For those exercises, large fires were started on the first and second floors using wooden pallets. The fires were built, ignited, allowed to grow to substantial size, and then trainees were instructed on how to properly extinguish them using conventional fire hoses. Once extinguished, the fires were re-built and the process was started all over again. Example images from various stages of this process can be seen in **Figure 11** below. The process continued all day as various groups of firefighters where instructed and practiced their skills. In the morning only the fire on the first floor was utilized, in the afternoon fires on both floors were ignited and used for training.
